Evaluation of Retrofit Procedures for Nail-Laminated and Stringer Bridges

EVALUATION of RETROFIT PROCEDURES for NAIL-LAMINATED and STRINGER BRIDGES

Final Report

July 2002

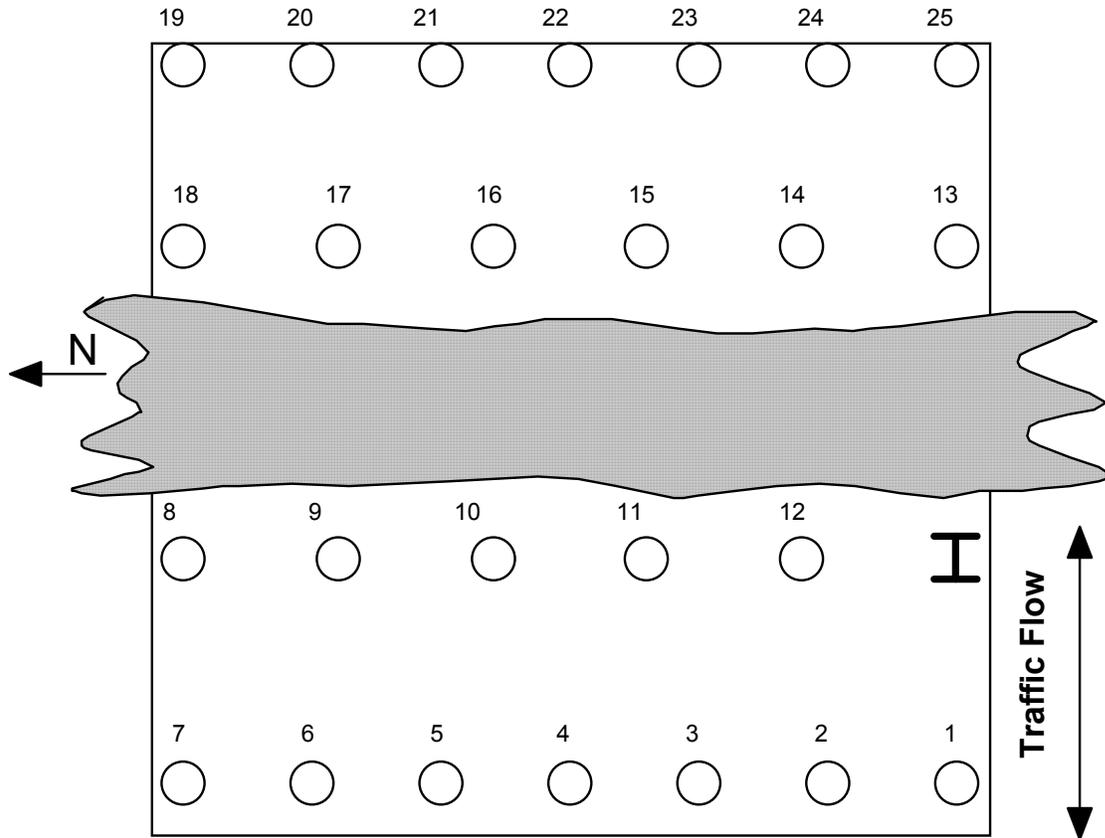
Figure 2.1. Plan View of Bridge Showing Piling Locations

- P1-P12** are located on the western half of the bridge.
- P1-P7** are abutment pilings, fully out of the water.
- P7-P12** are the second row of pilings from the west end; some of these pilings were within the stream at the time of inspection.
- P10** surface softening/decay 2.5 cm (1 in) inward from surface, beginning 15.2 cm (6 in) above ground; softening was determined using a flat-head screw driver or

pick.; breaks that do not produce splinters are most likely decayed. Surface of piling crumbled off when touched or broke away easily.

P6 surface softening/decay 2.5 cm (1 in) inward from surface; begins at groundline and extends below groundline.

P7 slight surface degradation; more localized than P6 and P10.

P1, P2, P3, P4, P5, P8, P9, P11 and P12 appeared to be sound and in good condition.

P13 piling needs replacement, severe physical damage, plant growth developing.

P16-P18 water level too high to adequately inspect at the groundline and below.

P17 should be inspected when water level decreases. Some surface softening was noticed.

The southeast side bridge diagonal bracing needs replacing. This diagonal has a large crack, probably resulting from the physical damage that caused the break in the adjacent piling (P13). This diagonal is attached to the lower end of P13 and extends to the upper portion of P16.

In October 1995, Robert Seavey and Maureen Peuttmann went to Sibley County to treat the piles which showed signs of decay. The following pilings were treated with CuRap™ 20: P10, P13, P14, and P16. CuRap™ 20 is a patented formulation containing copper naphenate and boraz (sodium tetraborate decahydrate), which is commonly used for remedial treatment of

All pilings except for P16 also received structural bracing, installed by Sibley County personnel.

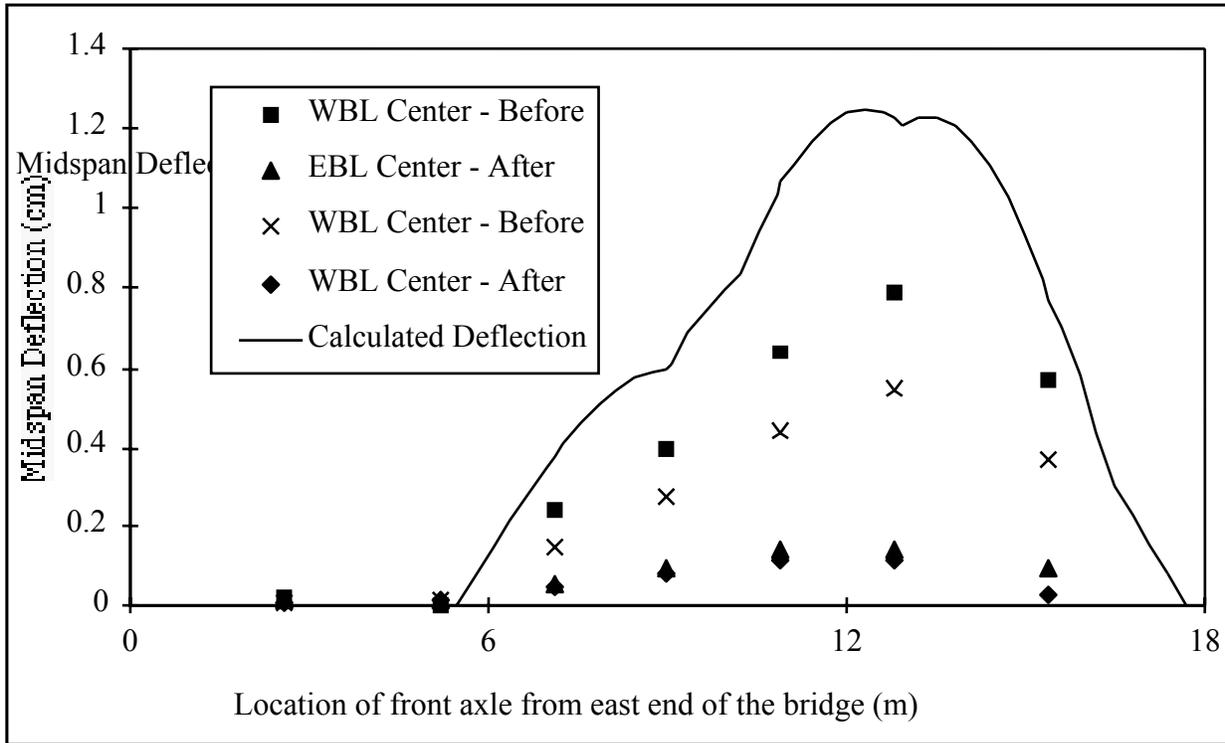
Figure 3.2. - Midspan Deflection of the Center Span: Before and After Retrofit

Figure 3.2 shows a representative selection of results from the static load tests before and after the retrofit. These results are plotted as single data-points and a curve of an elastic analysis of the bridge using a single stringer with a load distribution factor of S/4.0 (AASHTO Code Table 3.23.1, Appendix E page E1). The elastic analysis curve show the midspan deflection with respect to static test #1 (the front axle). The elastic analysis is for a single line of tires and is further adjusted by the load distribution factor. As stringer spacing is reduced, more stringers carry the tire loads, resulting in the reduced load distribution factor. The elastic analysis was performed to determine whether the midspan deflections observed in the static load tests were reasonable. The elastic analysis establishes an upper boundary for the static load test deflections. A stringer spacing of 58 cm (23 in.) was used for the elastic analysis because it yielded the best fitting curve. Regarding the results of the static load tests shown in Figure 3.2, the measured deflections seem reasonable.

Maximum static deflection values are an important part of the tests because they determine structural performance. With one lane loaded, the maximum deflection before retrofitting was 0.80 cm (0.315 in.). With both lanes loaded, the maximum deflection was 0.945 cm (0.372 in.). The elastic analysis established a maximum deflection of 1.23 cm (0.492 in.).

With only one lane loaded, the maximum static deflection drops from 0.795 cm (0.313 in.) in the original bridge, to 0.541 cm (0.213 in.) after the retrofit, a 32 percent decrease. With both lanes loaded, the maximum static deflection is reduced from 0.945 cm (0.372 in.) in the original to 0.702 cm (0.276 in.) after the retrofit, a reduction of 25 percent.

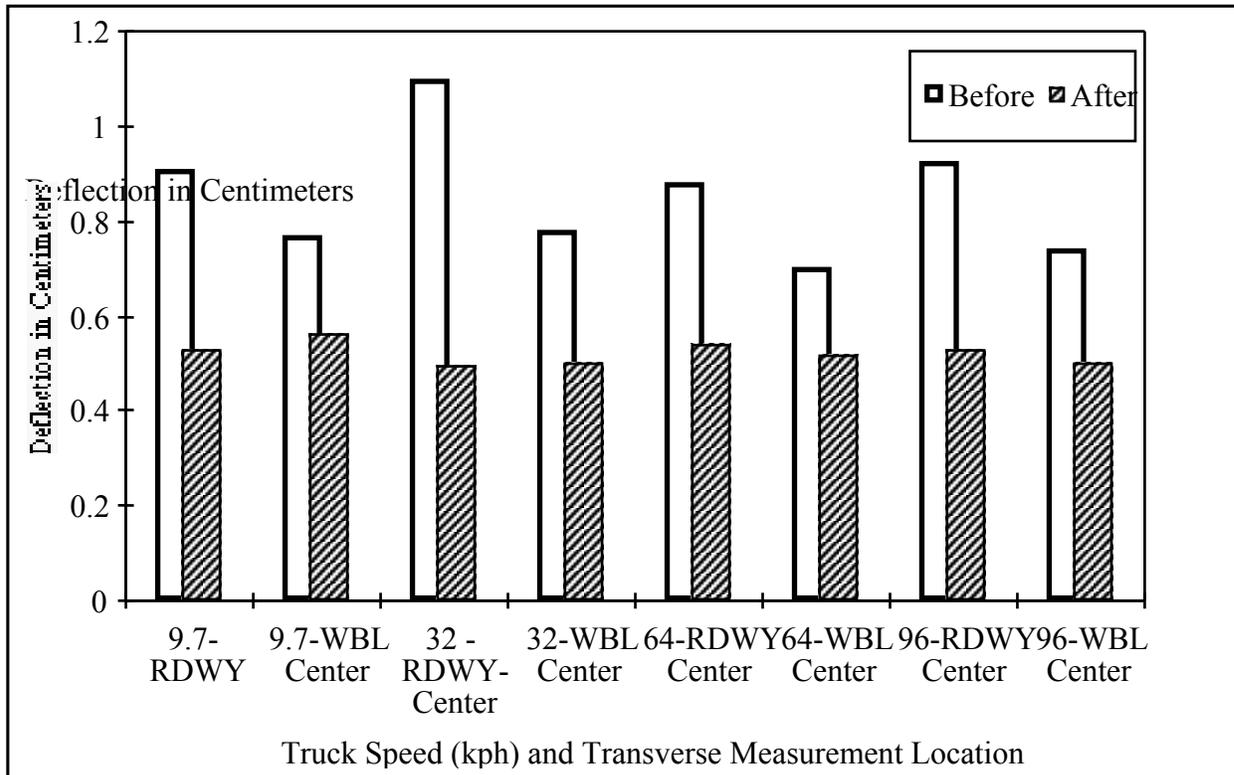
Figure 3.3. - Maximum Dynamic Deflections of the Center Span of the Timber Bridge Before and After Retrofit

Figure 3.3 shows the peak maximum deflections before and after the retrofit due to the rear tandems of two trucks traversing the bridge side by side at four different speeds. The magnitudes of the maximum dynamic deflections were similar to the maximum static deflections. There was significant vibration after the trucks left the bridge at 96 kph (60 mph) and 64 kph (40 mph) before

the retrofit. As seen in Figure 3.3, the maximum dynamic deflections before retrofitting were 1.102 cm (0.434 in) and 0.782 cm (0.308 in) at RDWY-C and WBL-C respectively, and they occurred at traffic speeds of 32 kph (20 mph). After the retrofit, there is less variation in the deflection between transverse location and truck speed.

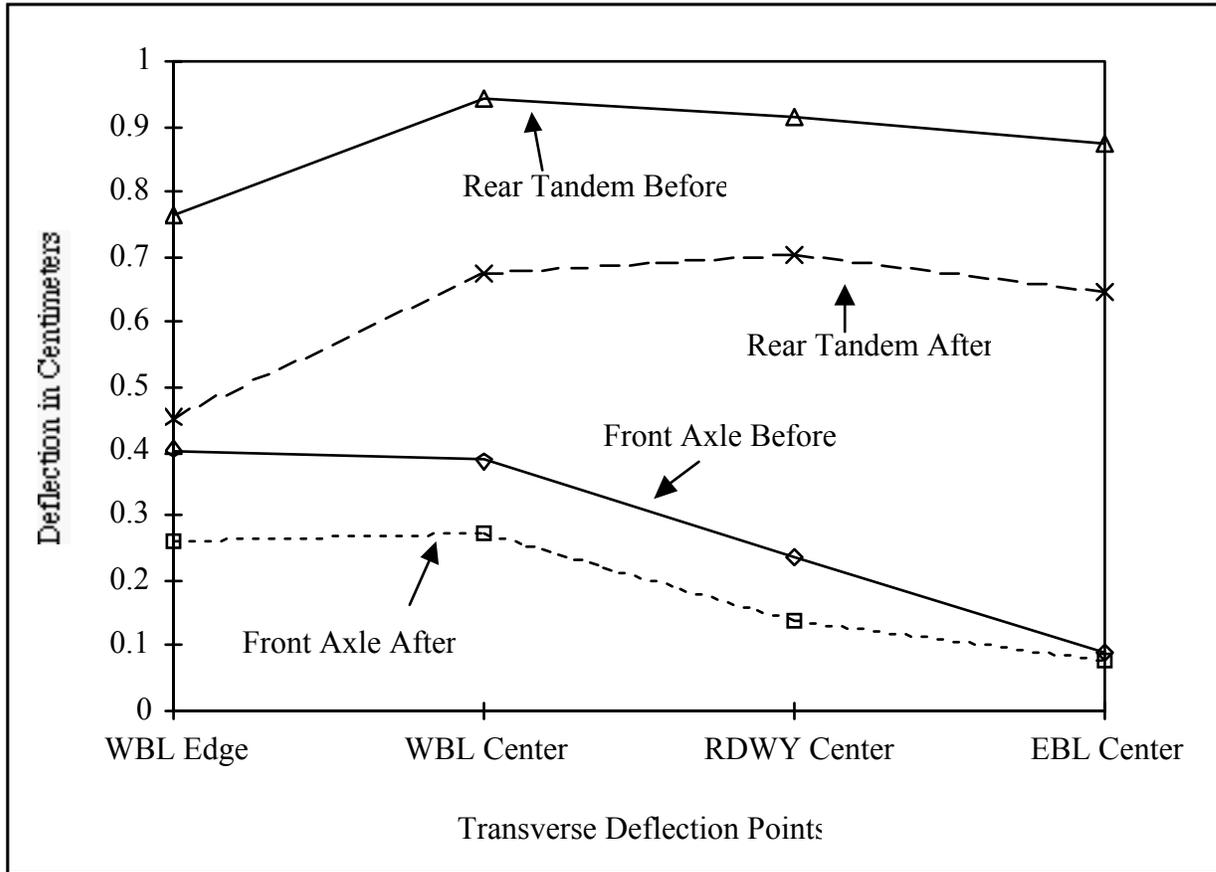
Figure 3.4. Transverse Deflections with Front Axle of One Truck and Rear Tandem of Two Trucks at Loading Points

Figure 3.4 shows the before-and-after deflection profiles across the center of the bridge with respect to the location of the: 1) front axle of one truck and 2) rear tandem of two trucks. Comparing results before and after, the retrofit the transverse load distribution has been improved by the retrofit. The convergence of the front-axle data going from WBL-C to the EBL-C, also indicates better load distribution in the retrofitted bridge. With the truck traveling in the east-bound lane, the deflection of the stringer at WBL Edge increased after the retrofit, which indicates a better distribution of the transverse load as a result of the retrofit. The reduction in RDWY-C deflection with two trucks also indicates a more uniform load distribution between stringers in the center span of the retrofitted bridge.

In addition to the retrofit deck, the two outboard beams (added in widening the bridge) probably helped to improve the transverse load distribution. They would have carried some of the load, especially with just one lane loaded. For example, this would have reduced the load carried by the WBL Edge stringer. The deflection in these new stringers was not measured and, therefore, their effect cannot be quantified.

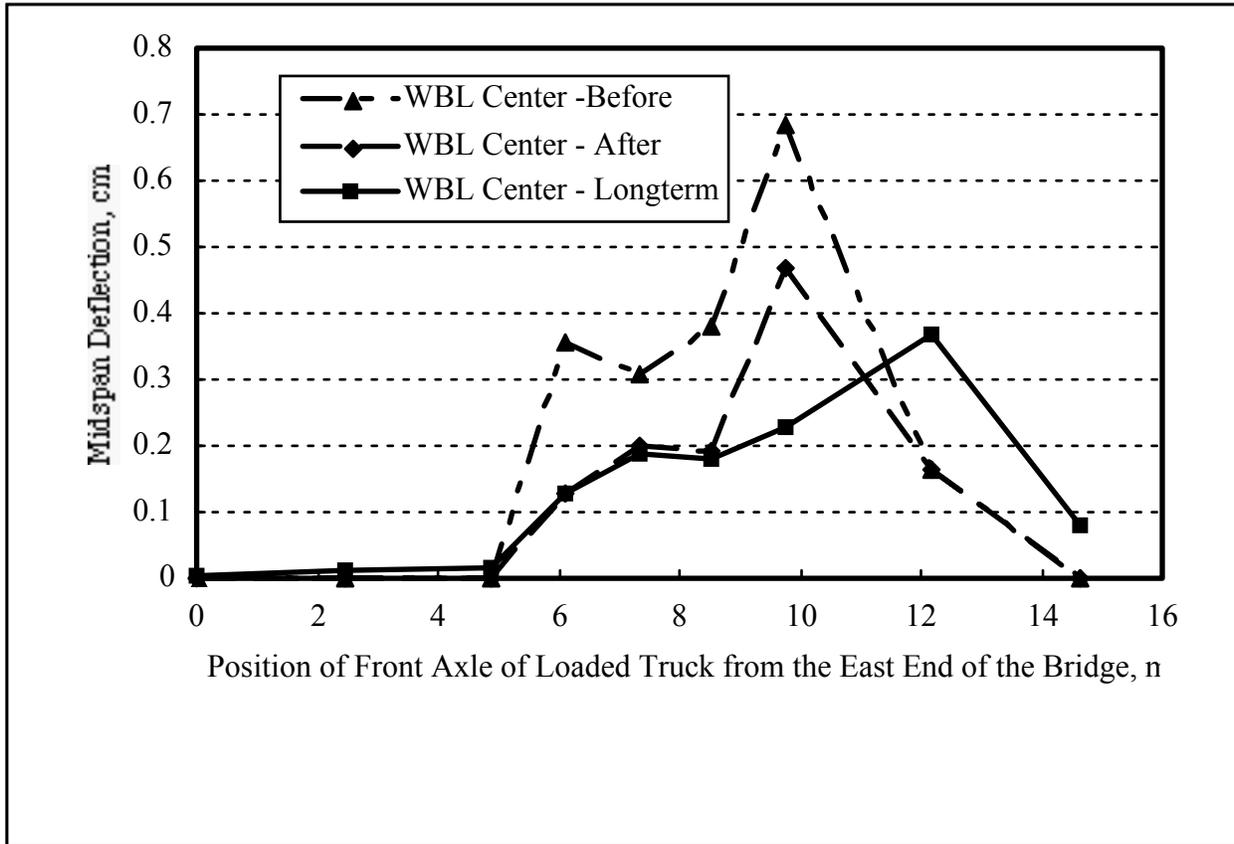
Figure 4.2 - Results of Static Load Testing of Nail-laminated Bridge

A representative result of the four, static load tests is shown in Figure 4.2. This figure gives midspan deflection as a function of front axle location, Test #1 described earlier. The maximum midspan deflection for the retrofitted bridge (as tested in 1995) was 0.37 cm. In 1992 the maximum deflection for the retrofitted bridge was 0.48 cm as seen in Figure 4.2. Before the retrofit, the maximum deflection was 0.69 cm with one lane loaded. Maximum deflection based on front axle location was reduced 46% from the original bridge to measurements taken in 1995. The shift in the maximum deflection to the right may have been from a slightly different transverse location of the truck during the test from earlier tests.

With both lanes loaded (Test #4), the maximum static deflection was 0.43 cm (0.17 in) in 1995. In 1992 the maximum deflection for the retrofitted bridge was 0.61 cm (0.24 in) and before the retrofit, with two lanes loaded the maximum deflection, was 0.76 cm (0.30 in). Based on the results from Test #4 a 43% reduction in maximum deflection was observed between the original bridge measurements and 1995 measurements.

According to these measurements, the retrofit continues to effectively reduce static deflections compared to those observed in the original bridge. The decrease in observed post-retrofit deflections from 1992 to 1995 is probably due to a change in moisture content of the retrofitted deck from near the fiber saturation point in 1992, to an equilibrium moisture content of 16% - 18% in

1995. Applying grout to the bridge deck would have increased the moisture content of the wood and thereby decreased the stiffness of the deck.

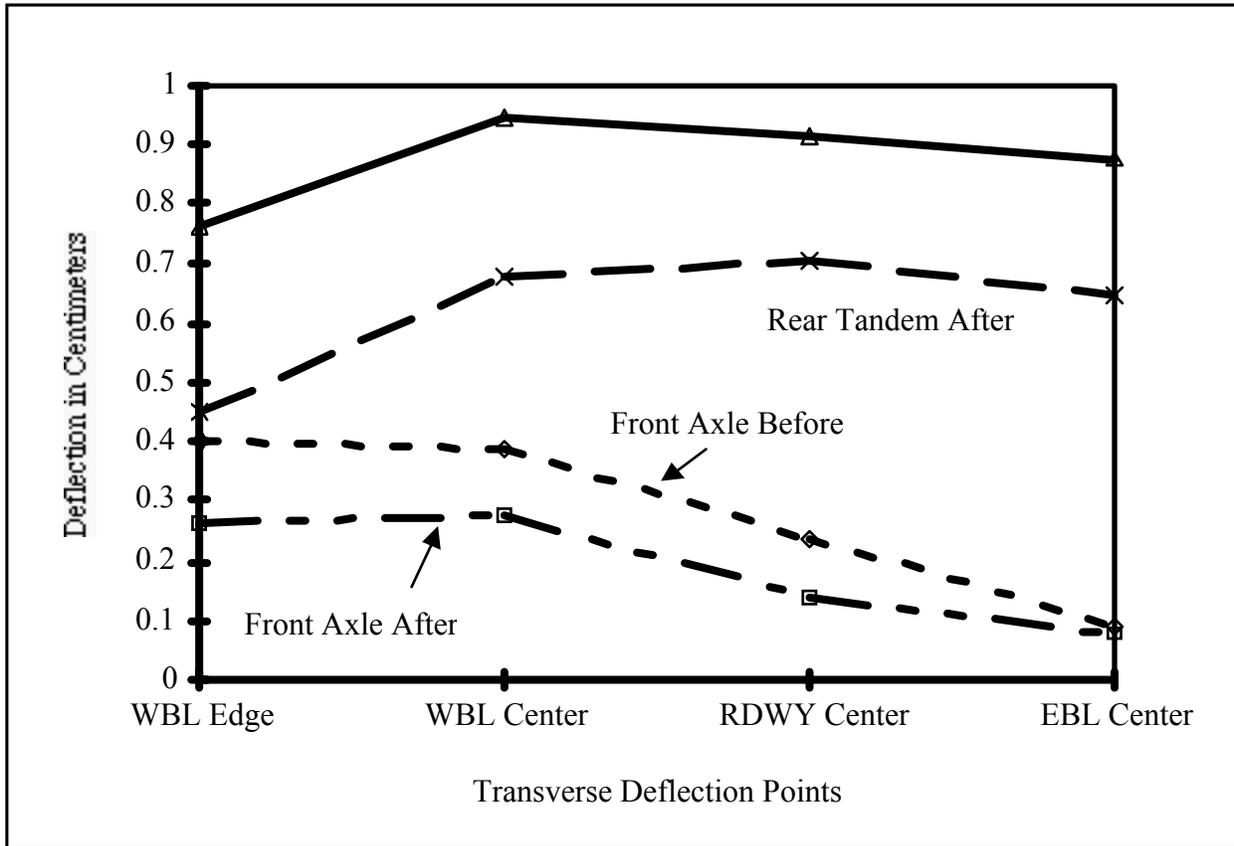
Figure 4.3 - Results Transverse Load Distribution of Nail-laminated Bridge

Figure 4.3 shows the observed deflection values from Test #4 for transverse load distribution as measured in 1992, both before and after the retrofit, and again in 1995. It shows that the immediate improvement seen in load distribution after the retrofit, has been sustained. Again one will observe a reduction in deflection from after the retrofit in 1992 to 1995. A possible factor is the lower moisture content of the transverse deck during the 1995 test, as mentioned earlier.
