Evaluation of Retrofit Procedures for Nail-Laminated and Stringer Bridges

EVALUATION of RETROFIT PROCEDURES for NAIL-LAMINATED and STRINGER BRIDGES

Final Report

July 2002

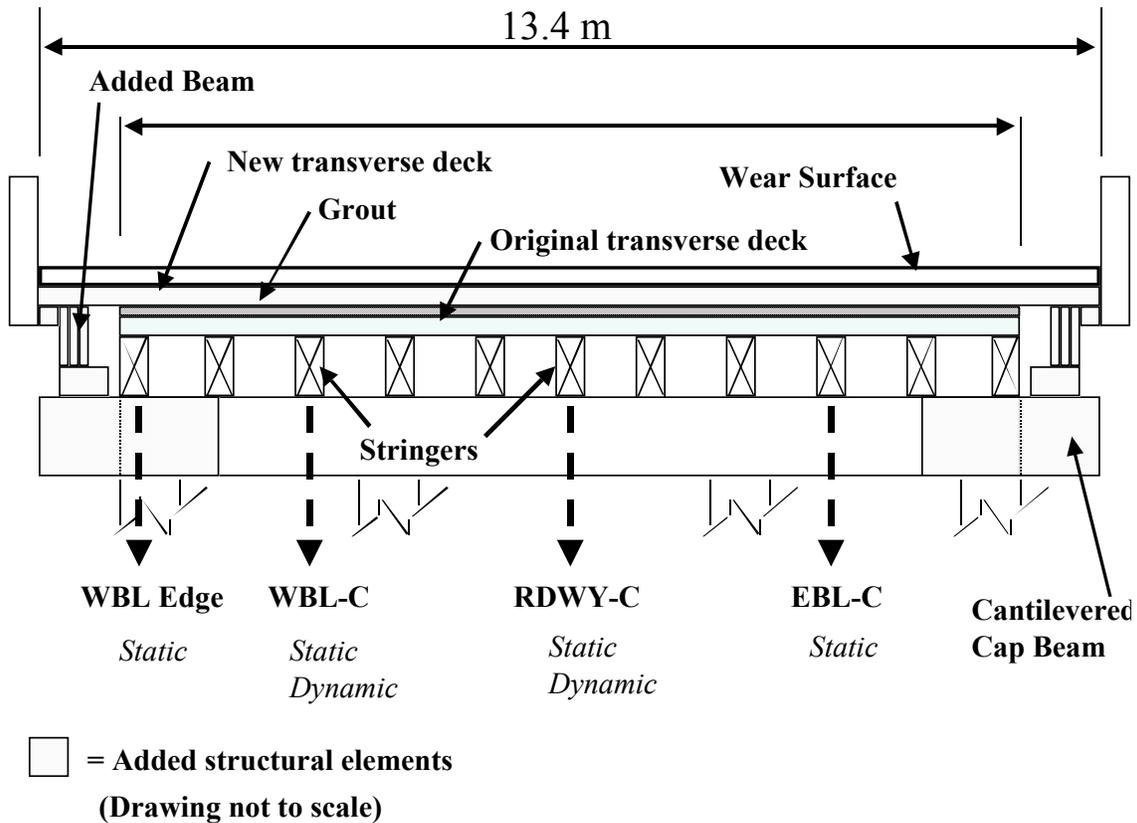
Figure 3.1 - Cross-section of Stringer Bridge

The first step in the retrofit process was to remove the old railing and bituminous overlay. Figure 3.1. is a cross-section of the retrofitted bridge showing the transverse pier cap beams which were extended 91cm (3 ft) at each end using bolted scabs. A longitudinal beam composed of three 10.2 cm x 35.6 cm (4 in x 14 in) stringers supported at each end of the scabbed cantilevers support the extended retrofit deck. Grout was poured and leveled to screed boards that were secured to the outer edge of the existing transverse deck. Prefabricated, nail-laminated panels were then laid transversely and secured, and a new railing system was installed. Finally, a bituminous wearing surface was laid over the full width of the new deck.

Deflections were measured using linear variable differential transformers (LVDTs). As shown in Figure 3.1, these were placed under the mid-point of four center span stringers. Each LVDT was calibrated before and after use to establish a direct correlation between voltage and displacement (i.e. 2.54 cm = 10.000 volts). A digital voltmeter, which enabled deflection readings

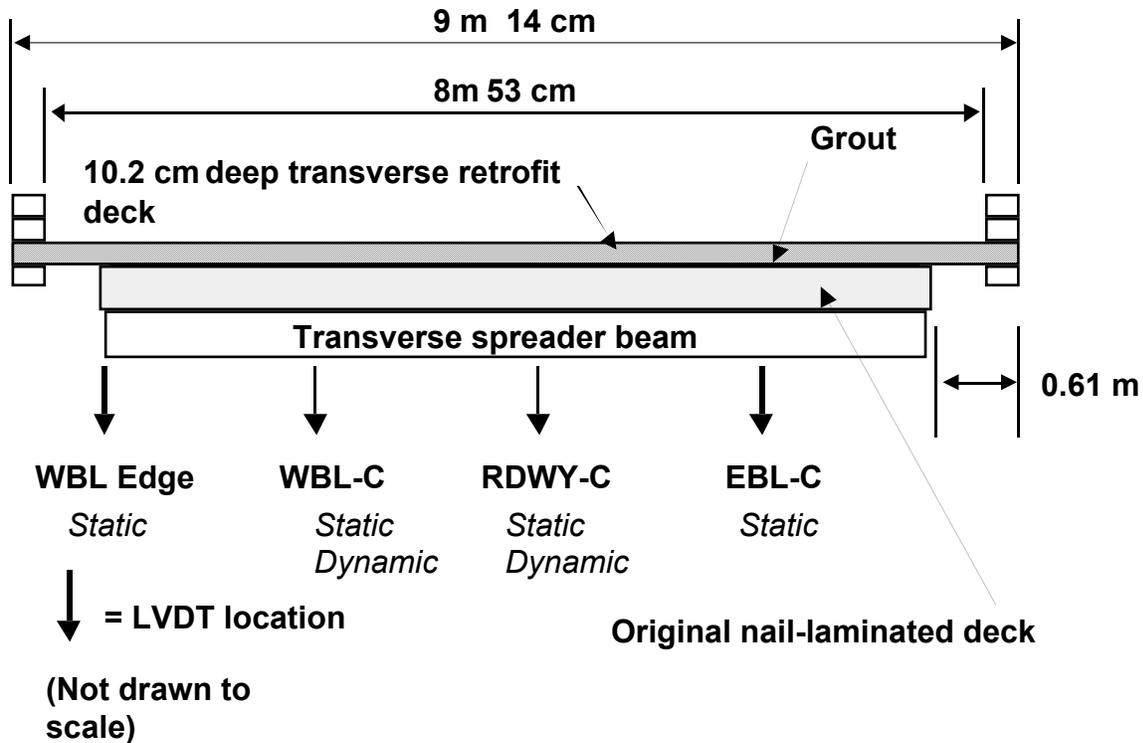
Figure 4.1 - Cross-section of Nail-laminated Bridge

Figure 4.1 shows the cross-section of the retrofitted bridge. Retrofit panels were 1.22 m wide, 9.14 m long and 10.2 cm thick, and contained pre-drilled grout holes spaced .91 m on center in both directions. After the retrofit panels were attached to the original bridge, a grout consisting of Type I portland cement, silica sand, water, and an admixture called Acryl 60, was pumped into the pre-drilled grout holes. The mix proportions by volume for the cement, silica sand, liquid mix were

Deflections were measured using linear variable differential transformers (LVDTs). As shown in Figure 4.1, these were attached to the underside of the center span transverse spreader beam. Each LVDT was calibrated before and after use to establish a direct correlation between
